Improved Suzuki Swift axial joint

| Sidem-nr | brand | make | OE-nr |
|---|---|---|---|
| 77115 | Suzuki | Swift IV (AZG, AZH) | 48830 68L00 |

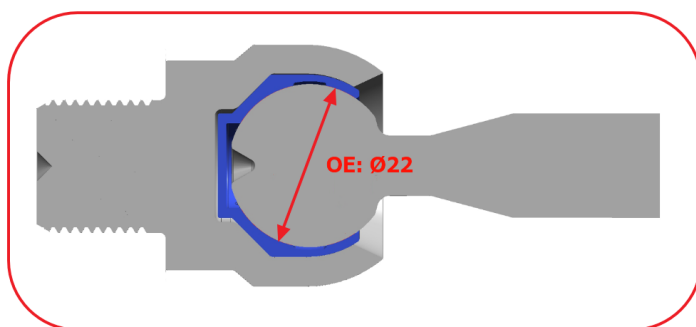
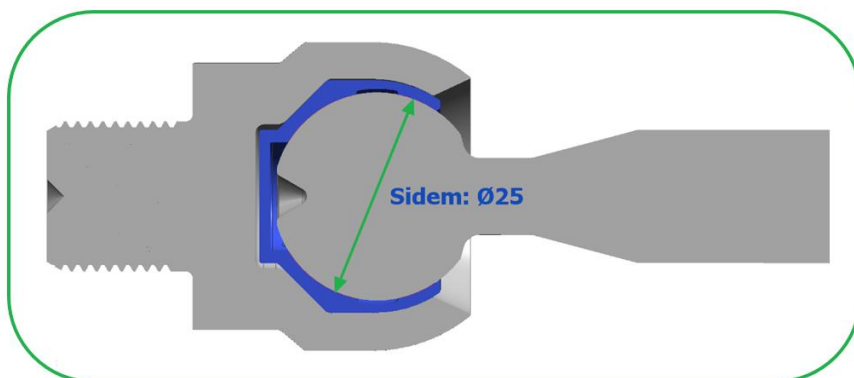
Early wear on the axial joint

Small diameter of ball ($\text{Ø}22$) resulting in a high strain on the surface of the insert

Noise and play in the axial joint

Increased diameter of the ballpin: $\text{Ø}25$
