Improved track control arm BMW E46

SIDEM	APPLICATION	N° OE
21278 R	Track control arm	BMW (E46)	31 12 6 777 851 R
21279 R	Track control arm		31 12 6 774 820 R

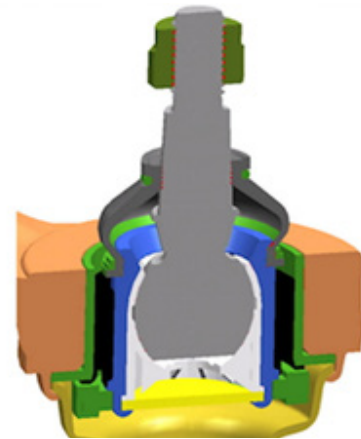
OE design

- Early wear of rubber bedding ball joint.
- Play on ball joint.

- Weak connection by rubber between inner and outer bushing.
- Damaged dustcover.
