# SIDEM SOLUTIONS

## Improved track control arm Audi

SIDEM	TOEPASSING	N° OE
37672/73	track control arm	Audi	8E0 407 505/6 P
37670/71			4D0 407 509/10 K
37972/73			8E0 407 509/10 P
37070/71			8K0 407 509/10 A
37078/79			8K0 407 505/6 A

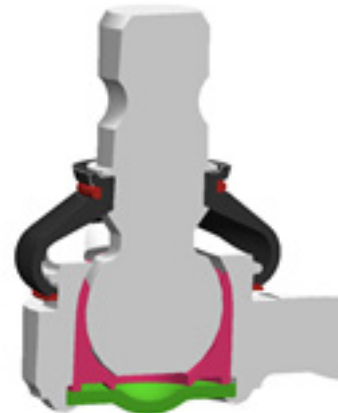
Original

- Play on Ball joint

- Due to its location, the track control arms are exposed to all kind of external influences. When a dustcover is damaged or is not fitting perfectly, water and dirt finds its way into the joint. This causes oxidization of the ball pin, which leads to wear of the plastic cup.
