## Preload on BMW

SIDEM	APPLICATION	N° OE
21570	track control arm	BMW 7-series E65/E66 TCA	31 12 6 774 831

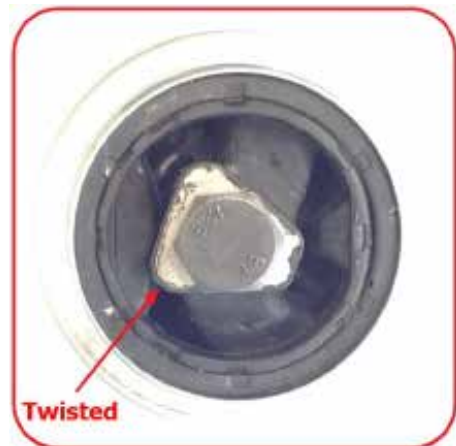
- Oil leak under front suspension and/or knocking noises at the front end of the car

- The center part of the silent-block was tightened in a wrong angle, while the car was not resting on its wheels.
