Total redesigned balljoint

SIDEM	APPLICATION	OE-NR.
81182	Ball joint	Hyundai I30 (FD) & I30 CW (FD)	51760 2R000
		Kia C'EEED (ED)	
		C'EEED SW (ED)	
		PRO C'EEED (ED)

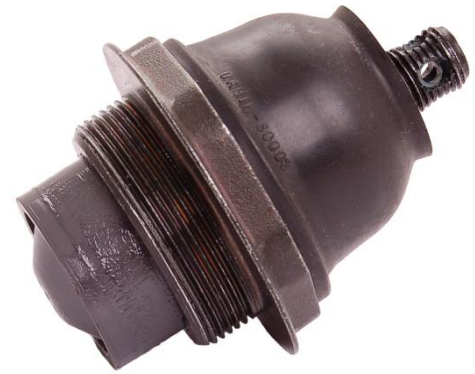
- Early clearance/backlash
- Cumbersome installation in the workshop by open concept of OEM

- Wear from dirt infiltration before or during the installation of the OEM piece.
- No correct tension during installation
 - too much tension -> high torque movement, causing premature wear on the plastic insert
 - too little tension -> clearance/backlash
