Improved Suzuki Swift axial joint

| Sidem-nr | brand | make | OE-nr |
|---|---|---|---|
| 77115 | Suzuki | Swift IV (AZG, AZH) | 48830 68L00 |

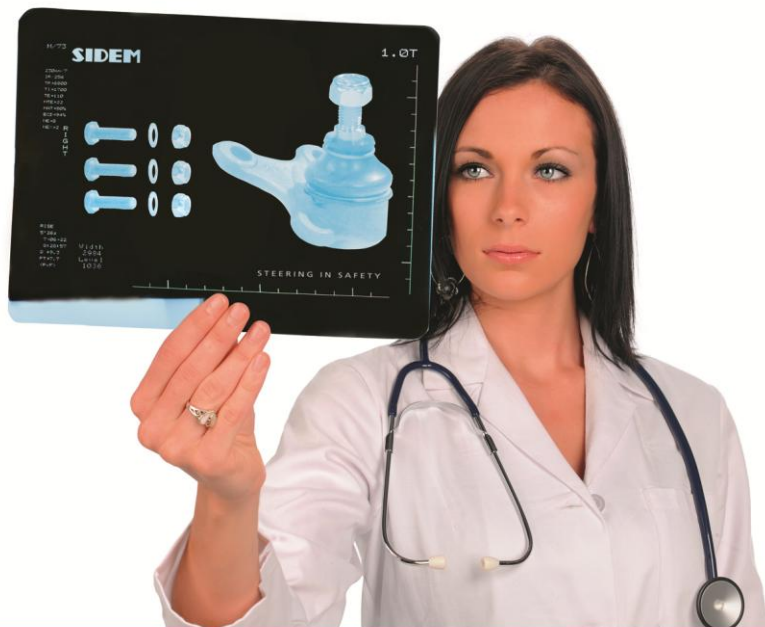
Early wear on the axial joint

Small diameter of ball ($\text{Ø}22$) resulting in a high strain on the surface of the insert

Noise and play in the axial joint

Increased diameter of the ballpin: $\text{Ø}25$
