# SIDEM SOLUTIONS

## Improved track control arm Audi

SIDEM	TOEPASSING	N° OE
37672/73	track control arm	Audi	8E0 407 505/6 P
37670/71			4D0 407 509/10 K
37972/73			8E0 407 509/10 P
37070/71			8K0 407 509/10 A
37078/79			8K0 407 505/6 A

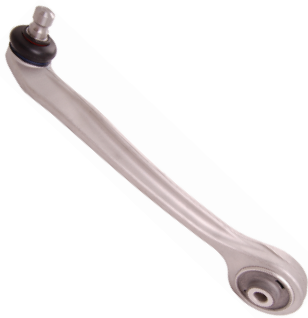
- Play on Ball joint

- Due to its location, the track control arms are exposed to all kind of external influences. When a dustcover is damaged or is not fitting perfectly, water and dirt finds its way into the joint. This causes oxidization of the ball pin, which leads to wear of the plastic cup.

- A new dustcover is designed with a perfect fit along the rod.
- A new rod is designed with an improved neck shape to ensure tight closing of the dustcover during movement.
