## Preload on BMW

SIDEM	APPLICATION	N° OE
21570	track control arm	BMW 7-series E65/E66 TCA	31 12 6 774 831

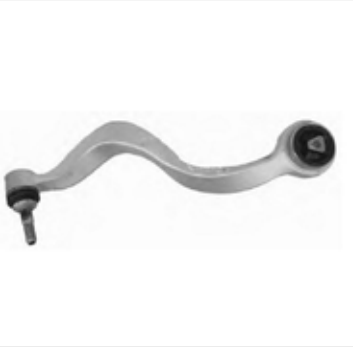
- Oil leak under front suspension and/or knocking noises at the front end of the car

- The center part of the silent-block was tightened in a wrong angle, while the car was not resting on its wheels.

- Always make sure to tighten the silent-block bolts of traction arms when the suspension is in its normal operating situation.
