Improved tie rod end Audi, Skoda & Volkswagen

SIDEM	TOEPASSING	N° OE
37630 R	tie rod end	Audi A4	4F0 419 811 E
		Audi A6	
		Audi A8	
		Skoda Superb	
		VW Passat IV/V

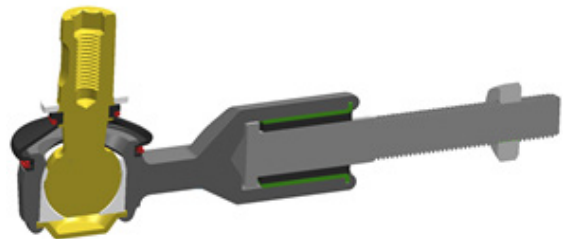
- Reduced lifetime

- Silent block tears out
- Silent block becomes softer during time

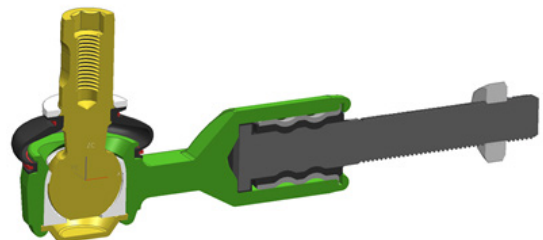
- The silent block is replaced by a rigid connection

- Longer lifetime
- No loss of steering accuracy
