## Improved silent block Alfa Romeo

SIDEM	APPLICATION	OE-NR.
35172	track control arm	Alfa Romeo GT, 156, 147	518 34 093
35173	track control arm		518 34 094
835613	silent block		part of

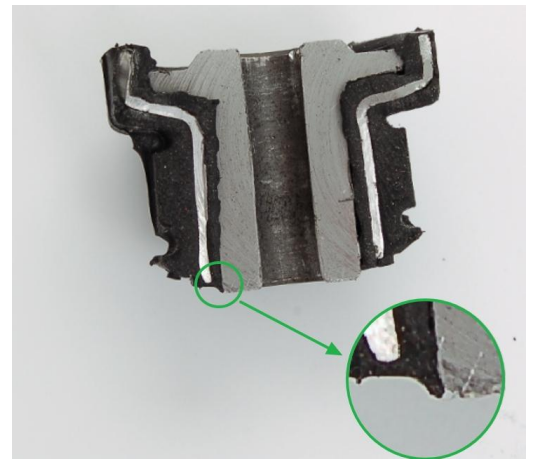
- significant positive effect on longevity

- An extra closing lip against the rotating inner bush results in a better sealing.
- Special synthetic grease is used which has an extremely water repellent effect.
